Manhole Inspection Summary

Manhole # S19MM_020MH

Location Address: **2143 WINDSOR AVE**

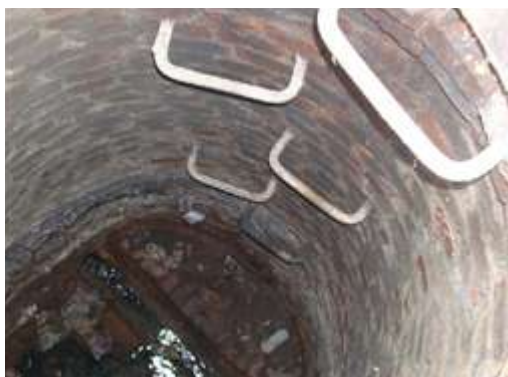
Defect 2

Steps Count: **7** Missing: **0** ☒ **Corroded**

Surcharge ☒ **Evidence Of Surcharge** Depth: **3** (ft.) ☐ Active Surcharge Present

CORODCED STEPS AND SURCHARGE
EVIDENCE

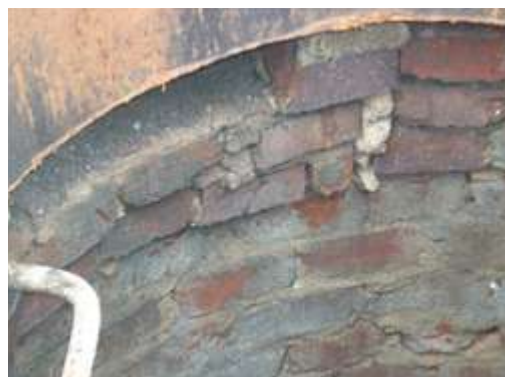
Defect 1

Chimney / Frame Adjustment ☒ Exists Material: **Brick** ☐ Parged Height: **6** (in.)

Condition: ☐ Sound ☐ Cracked ☐ Root Intrusion ☐ Loose Brick ☒ **Deteriorated**

DETERIORATION OF CHIMNEY

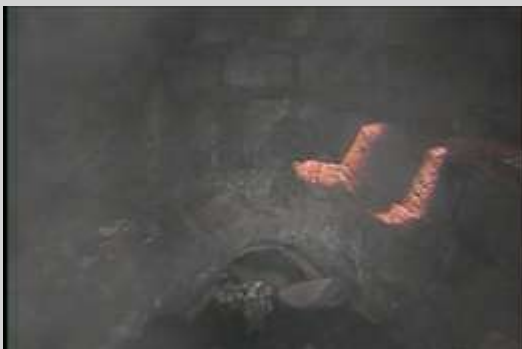
4 O'Clock Inflow

Deposits: ☐ None ☐ Mud ☐ Sludge ☒ **Debris** ☐ Grease

Silt Depth: **4** (in.) Deposits Extent: **Medium**
